NATIONAL PROGRAM FOR INSPECTION OF NON-FEDERAL DAMS
PAMECHA POND DAM (CT.) (U) CORPS OF ENGINEERS WALTHAM
MA NEW ENGLAND DIV JUL 80

4. TITLE (and Subtitle) Pameacha Pond Dam		5. TYPE OF REPORT & PERIOD COVERED INSPECTION REPORT
NATIONAL PROGRAM FOR INSPECTION OF NON-FEDERAL DAMS		6. PERFORMING ORG. REPORT NUMBER

PAMEACHA POND DAM
CT-00145

INSPECTION REPORT

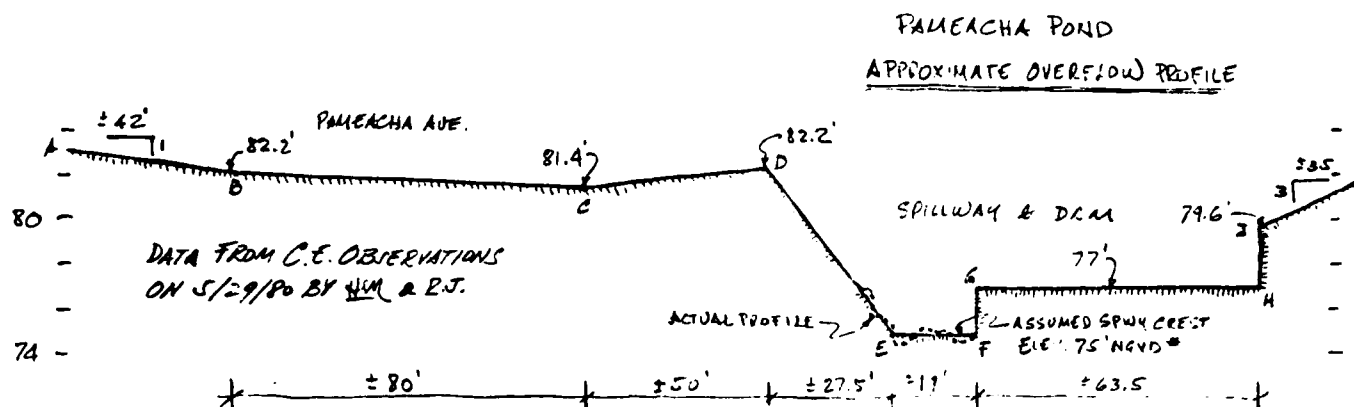
ASSUME $C=2.5$ FOR THE ENTIRE OVERFLOW SECTION.

*NOTE: W.S. ELEV. 75' NSL ON THE USGS MIDDLETOWN, CT QUADRANGLE SHEET (REV. 1972) IS ASSUMED TO BE THE AVERAGE SPILLWAY CREST ELEVATION ON NATIONAL GEODETIC VERTICAL DATUM.
